# Manhole Inspection Summary

Manhole # S21I\_\_030MH

Insp Date: **9/24/07 12:52 PM**

**Location** Address: **27 FULTON AVE**

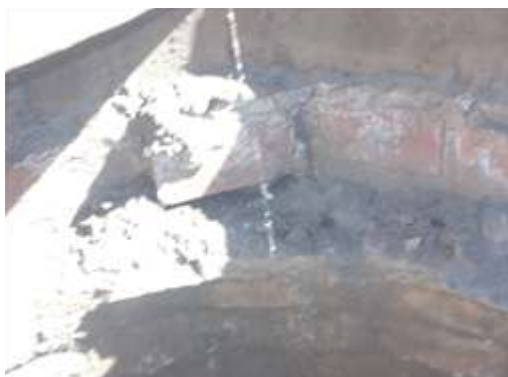
Defect 2

Condition: ☐ Sound ☐ Cracked ☐ Root Intrusion ☒ **Loose Brick** ☐ Deteriorated

LOOSE CHIMNEY BRICKS

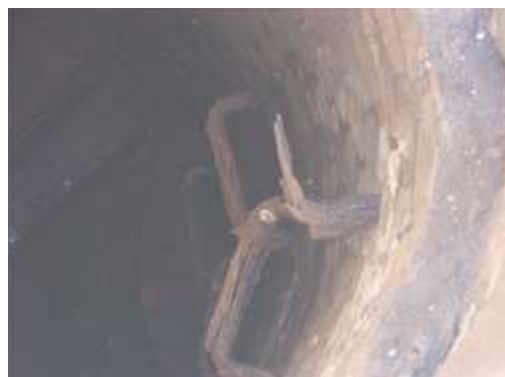
Defect 3

Count: **4** Missing: **1** ☒ **Corroded**

MISSING AND CORRODED STEPS

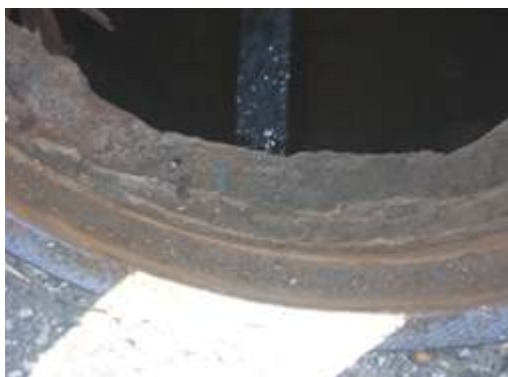
Defect 1

Offset: **3** (in.)

FRAME OFFSET

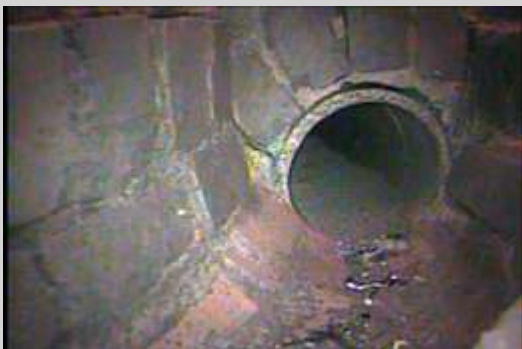
3 O'Clock Inflow

Pipe Height: **7.2** (in.) Rod and Bar (Angled)  
Pipe Material: **Clay** ☐ Pipe Lined  
Invert Depth: **9.79** (ft.) Flow Characteristics: **None**  
Deposits: ☐ None ☒ **Mud** ☐ Sludge ☐ Debris ☐ Grease  
Silt Depth: **1** (in.) Deposits Extent: **Light**  
Infiltration: **None** Pipe Seal Cond: **Sound**
